BIRCHWOOD LAKE DAM

NJ 00417

PHASE 1 INSPECTION REPORT NATIONAL DAM SAFETY PROGRAM

May, 1979

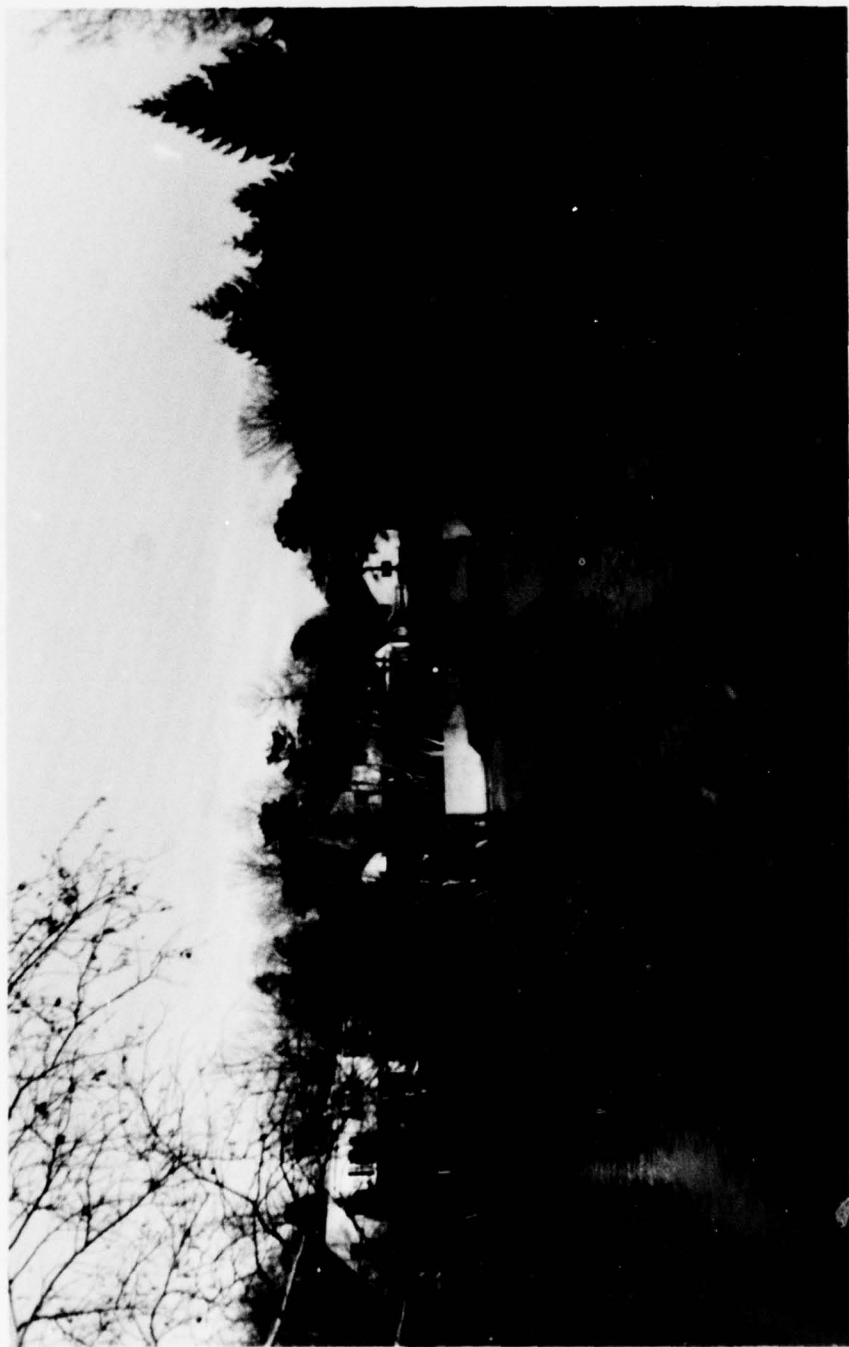
OVERVIEW - BIRCHWOOD LAKE DAM

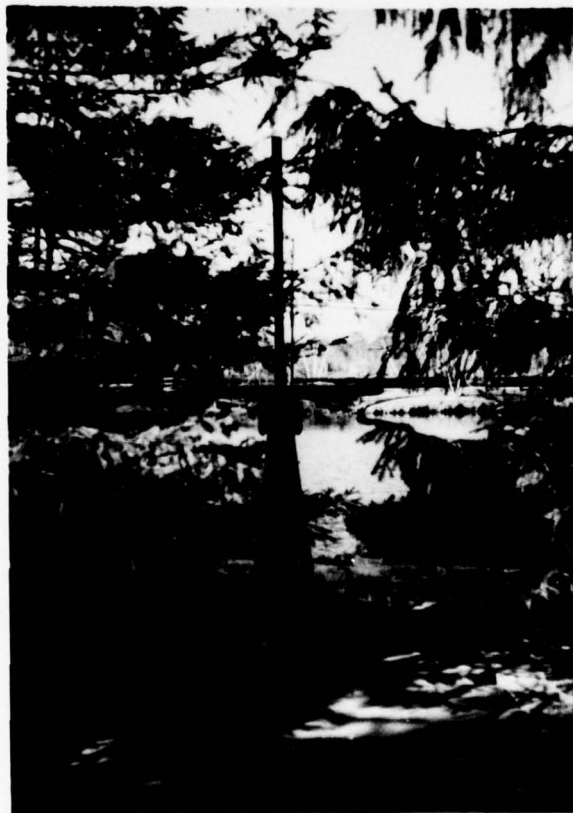
Maintenance of operating facilities such as the outlet works and the embankment sprinkler system is performed on an "as needed" basis. Approximately six years ago, the slide gate was replaced with stoplogs when the operating mechanism became inoperable.

PHOTO 2
OUTLET WORKS
OPERATING
MECHANISM.

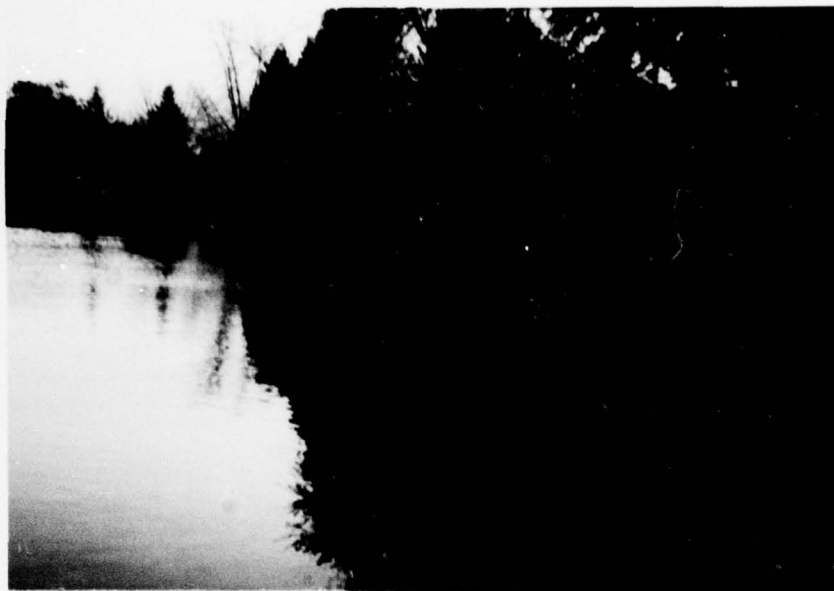
VISUAL EXAMINATION OF	OBSERVATIONS	REMARKS OR RECOMMENDATIONS
GENERAL	Embankment is grass covered (well kept stand) Some mulch, small birch trees and ground cover on upstream and downstream faces. Large pine trees planted along top.	Sprinkling system observed

PHOTO 3
UPSTREAM FACE OF EMBANKMENT.

1. Trees on the dam embankment should be removed. All trees should be cut at the ground surface.
2. The concrete spillway should be thoroughly inspected and repaired as outlined below:
 - a. Drain the lake to an elevation equal to the invert of the outlet pipe.
 - b. Sand blast all concrete and pressure grout all major cracks and patch any observed spalls and eroded surfaces.
 - c. Apply an epoxy preservative coating to all surfaces.
3. Debris accumulated in the outlet works should be removed.
4. A detailed design for a regrading of the upstream and downstream embankment slopes should be prepared by a qualified professional engineer and the embankment regraded accordingly.
